## PHASE 1 MILESTONE INSPECTION SUMMARY REPORT

Placido Gardens  
4535 1<sup>st</sup> Street North  
Saint Petersburg Florida

Regarding: Summary of the Milestone Inspection

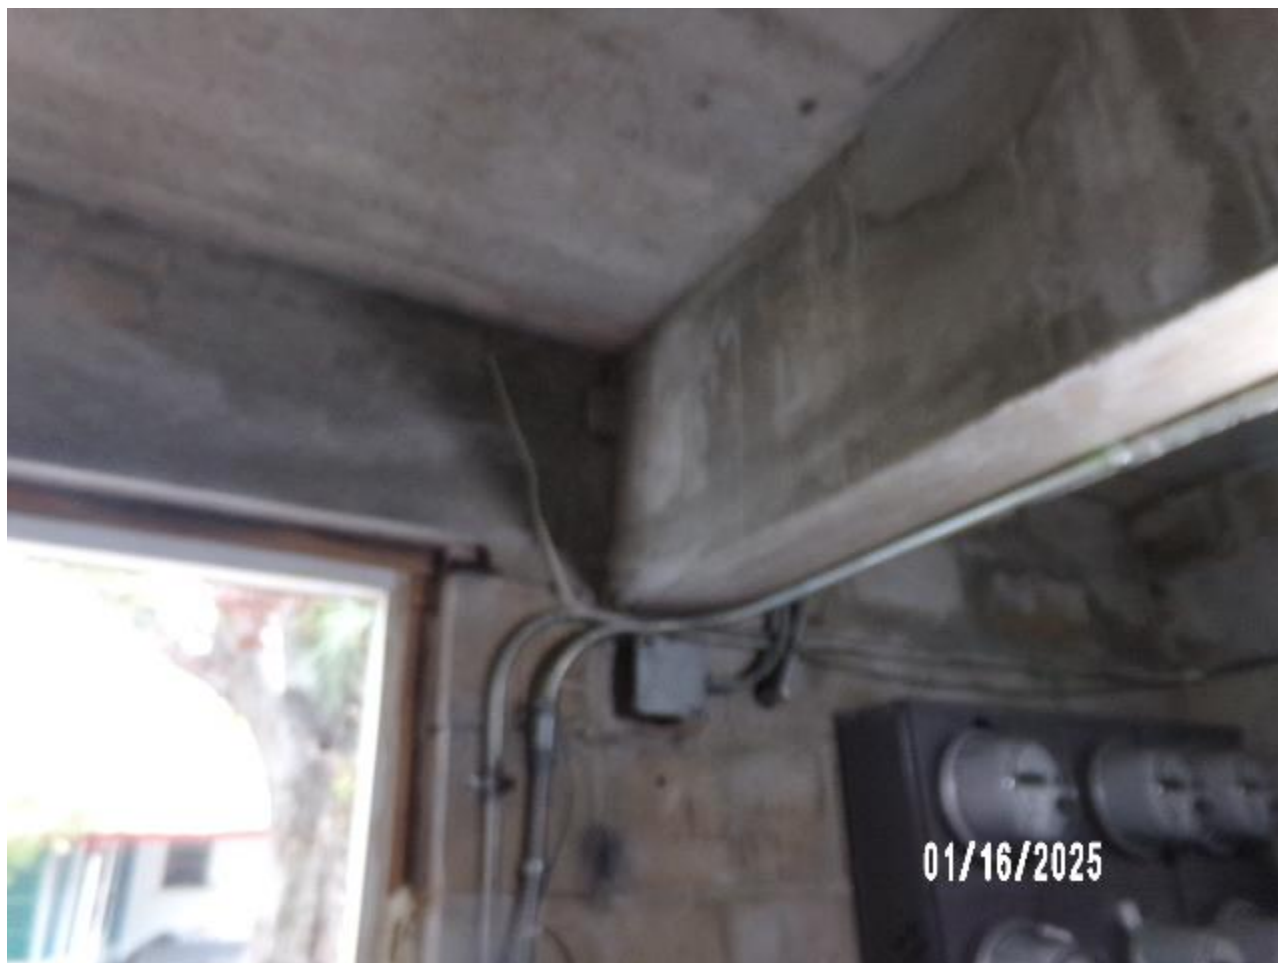
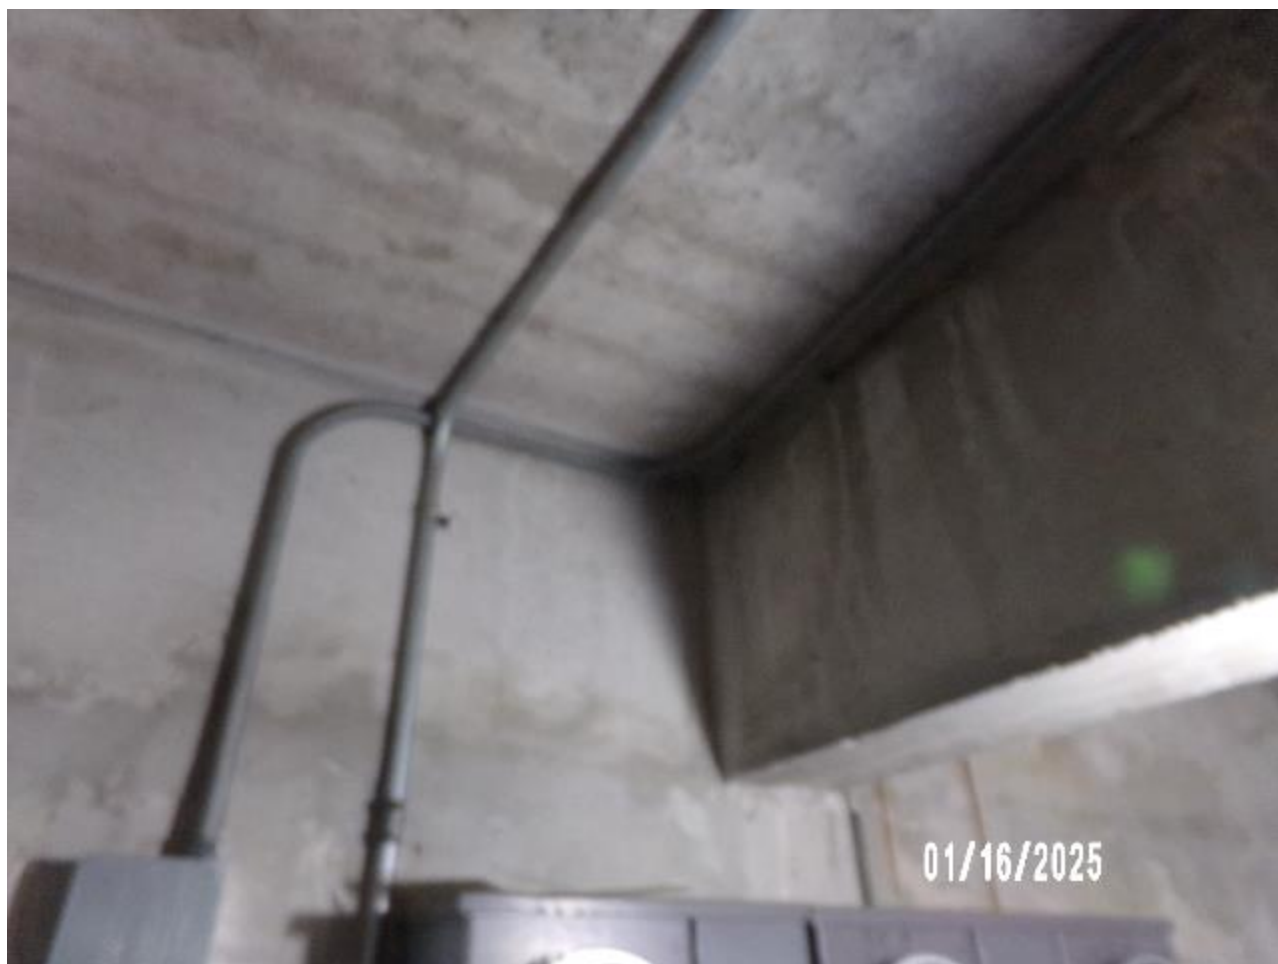
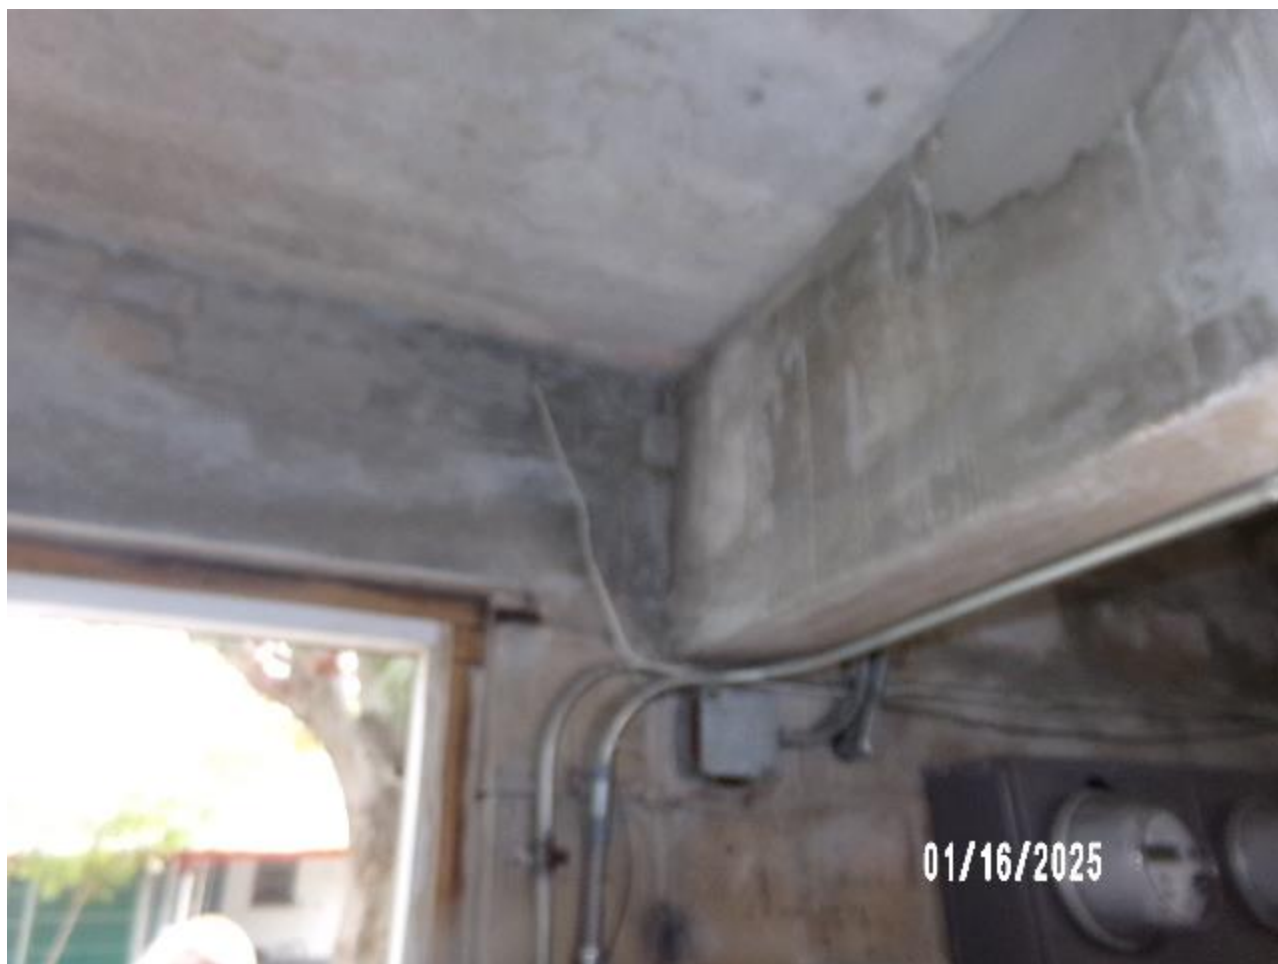
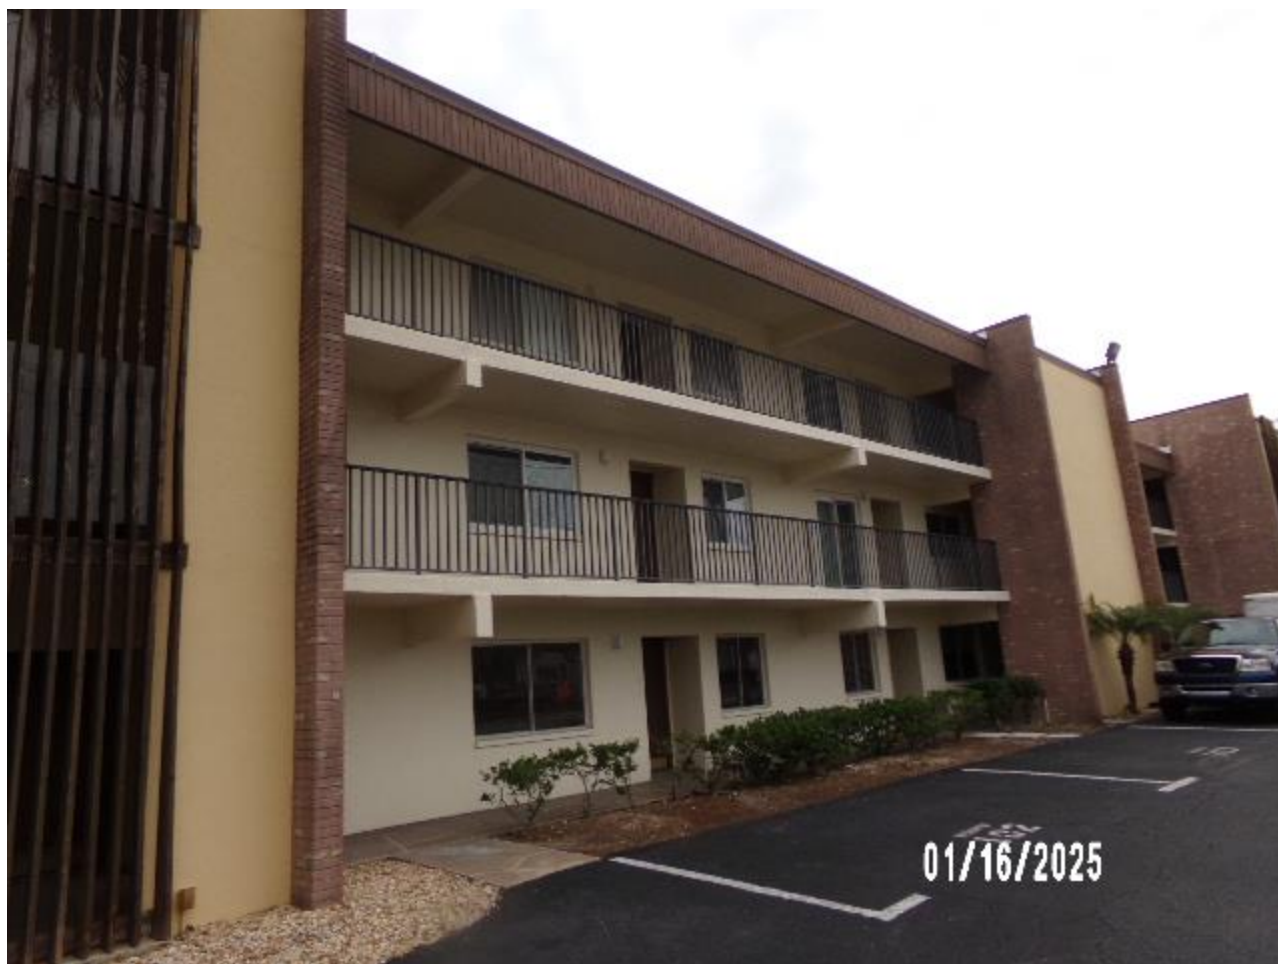
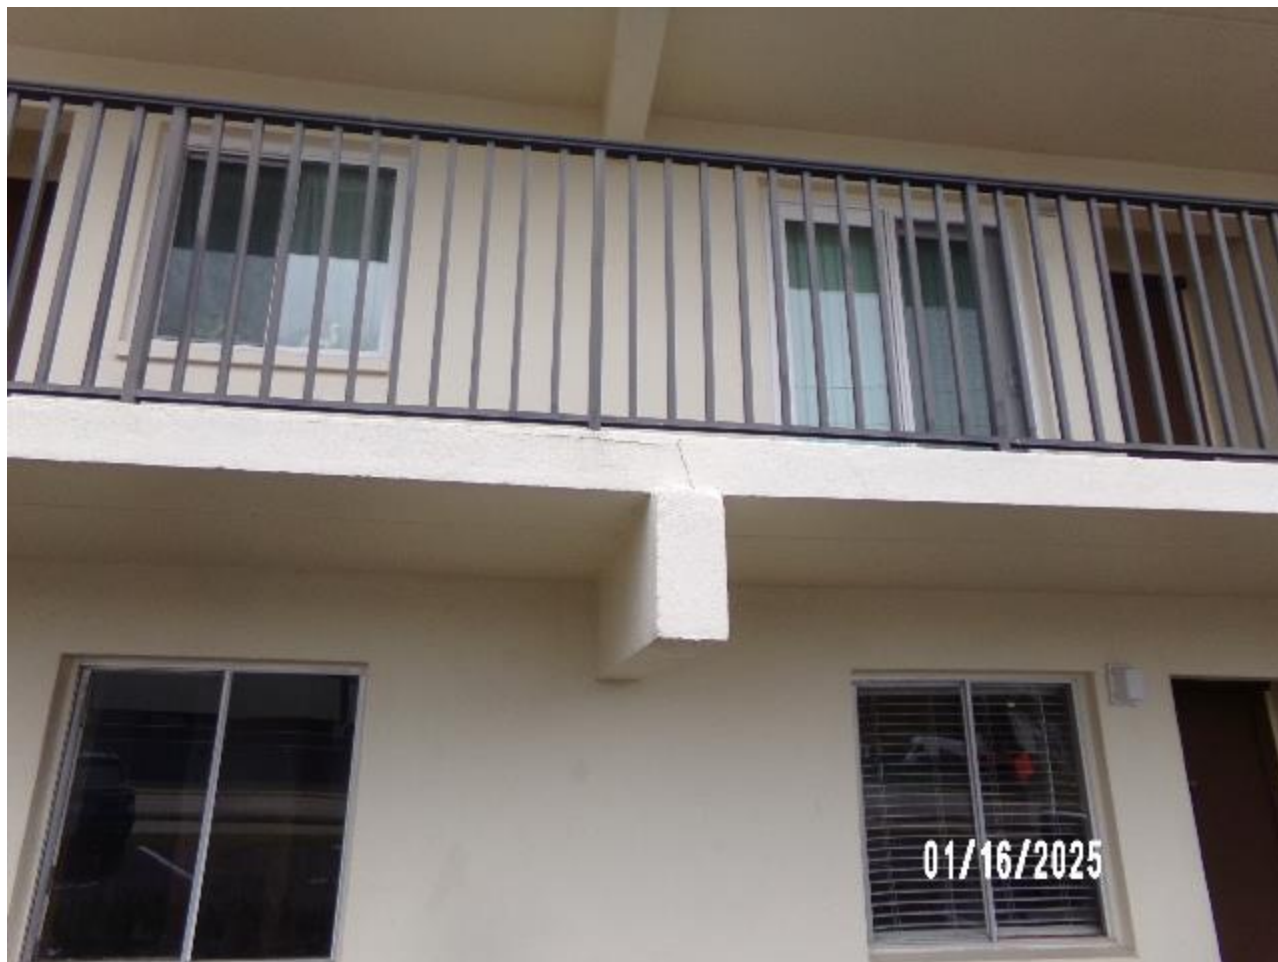
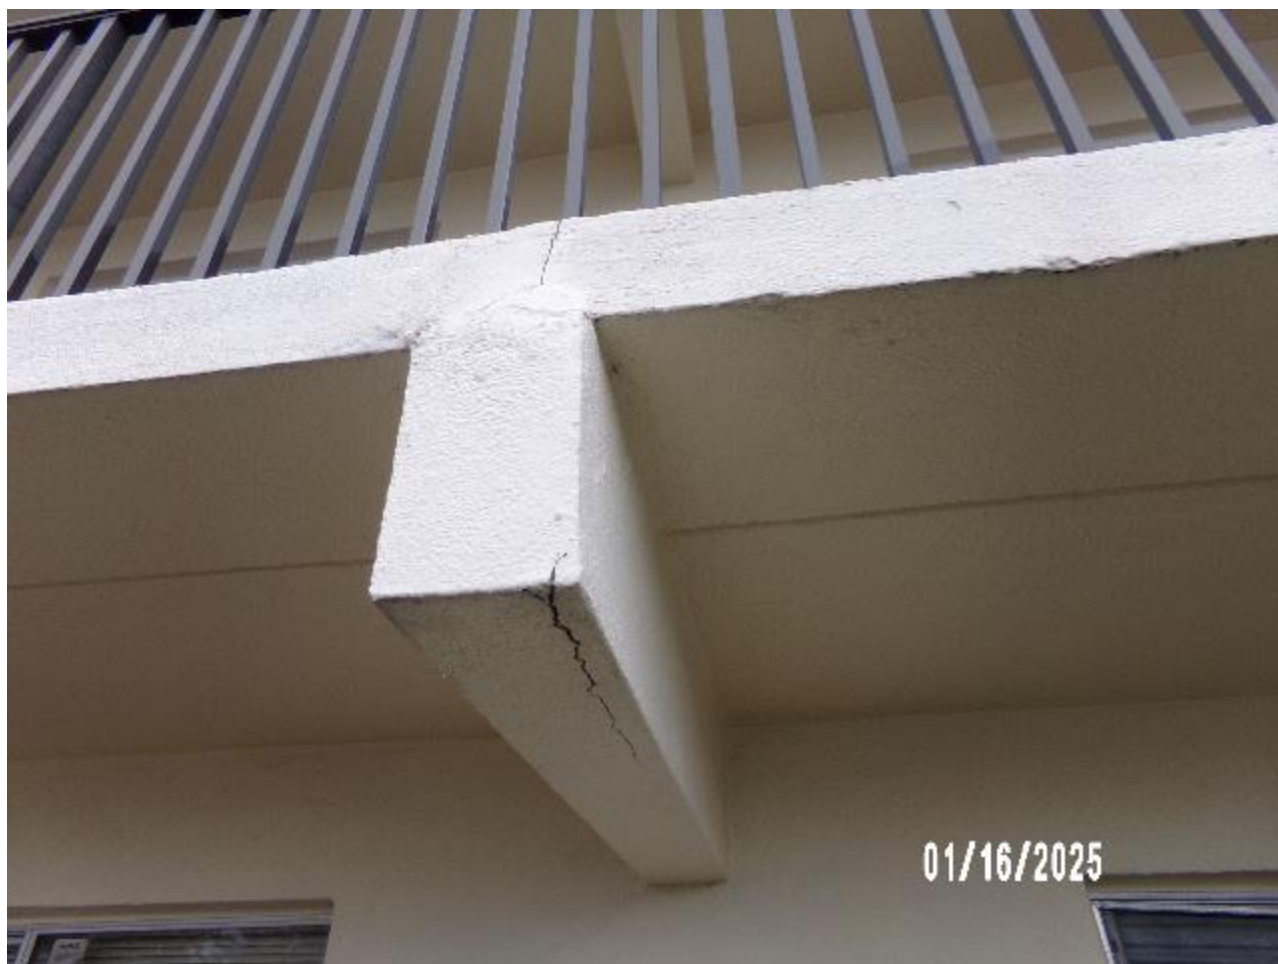
**PHOTO ATTACHMENTS:**

- **Concrete cracking at Laundry room door Jamb and minimal spalling at PIP concrete ceiling beam-** Repair recommended. This indicates an issue of note at the time of inspection that is NOT required to be repaired in order to pass the Phase One Milestone, but the association should be made aware of and make every effort to repair quickly. EIRS recommends repair of beam and Jamb within 6 to 9 months.
- **Corner beams at front side (west) of building that support walkways.-** Repair recommended. This indicates an issue of note at the time of inspection that is NOT required to be repaired in order to pass the Phase One Milestone, but the association should be made aware of and make every effort to repair quickly. There are cracking and spalling in two locations that EIRS recommends repair to these areas within 6 to 9 months,
